Inspection Report

Northeast Expedite Home Inspections LLC

Ossipee, New Hampshire
03814

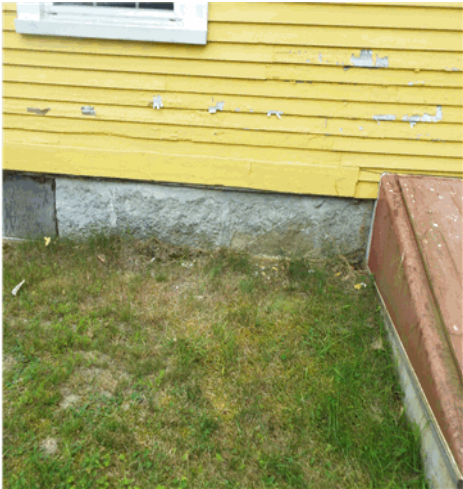
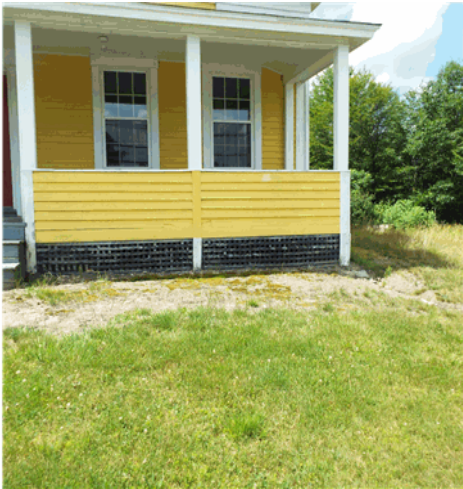
1) Grading Conditions

Appeared to be in serviceable condition at time of inspection.

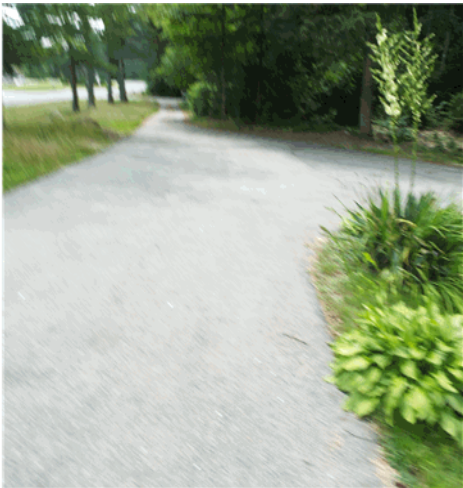
2) Driveway Conditions

The driveway appeared to be in serviceable condition at the time of the inspection. Common cracks were observed in the driveway.

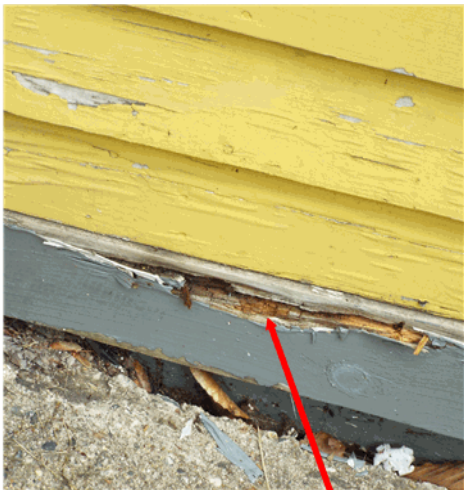
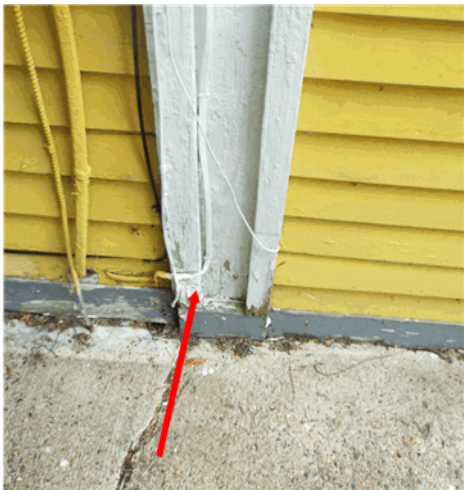
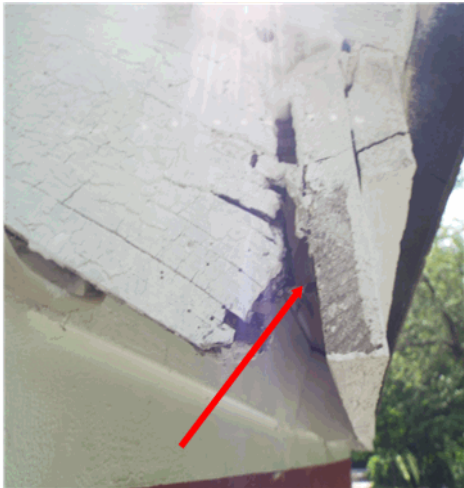
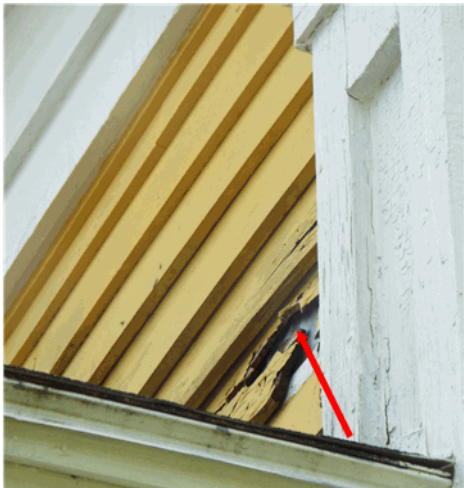
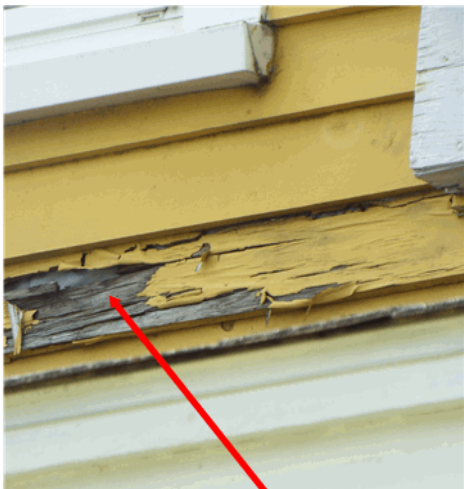
6) Exterior Wall Conditions R Damaged siding, trim and clapboards was observed . Due to conditions observed, further evidence may exist in areas not readily visible or accessible. Water penetration may have occurred. It is suggested that a "Licensed General Contractor" be contacted for further evaluation and repair.

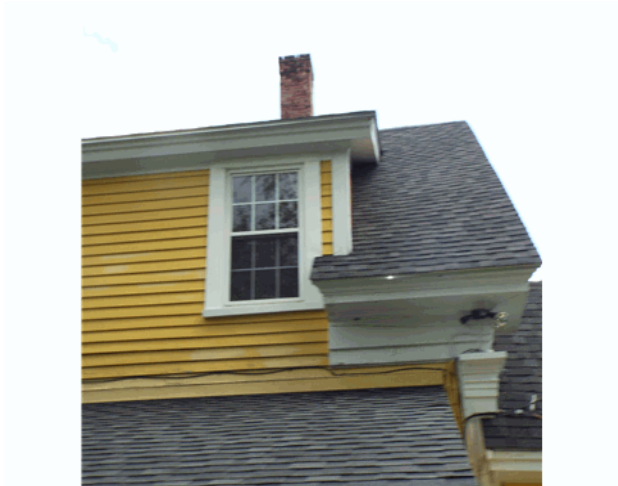
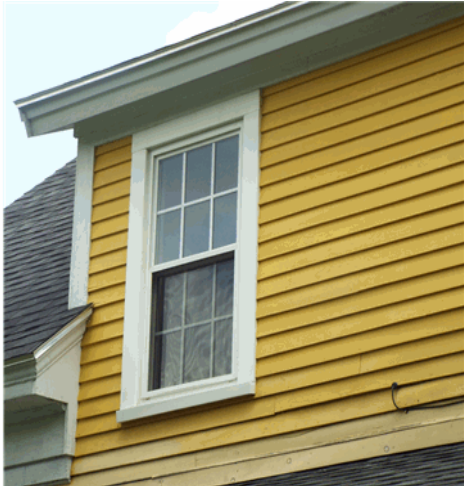
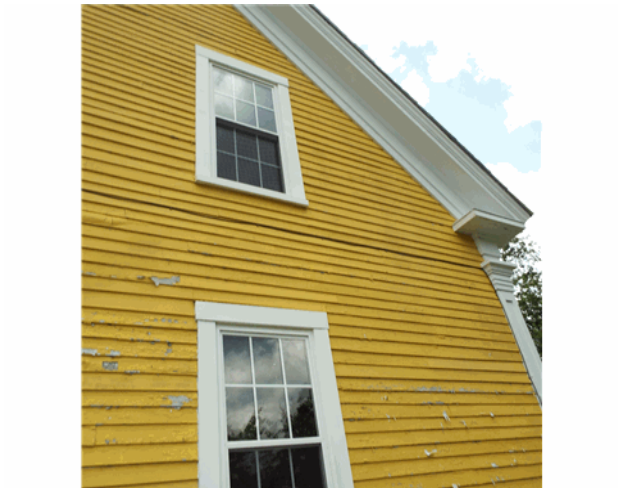
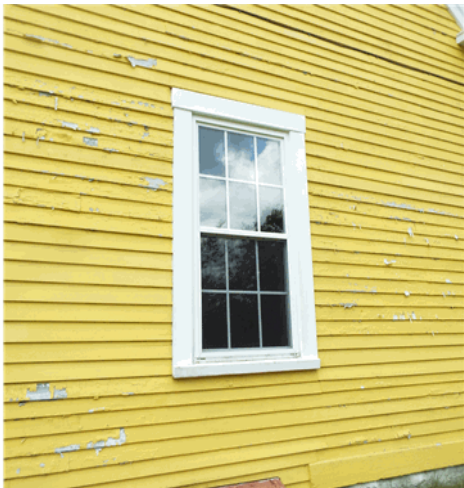
7) Window Conditions

Windows appeared to be in good condition a time of inspection.

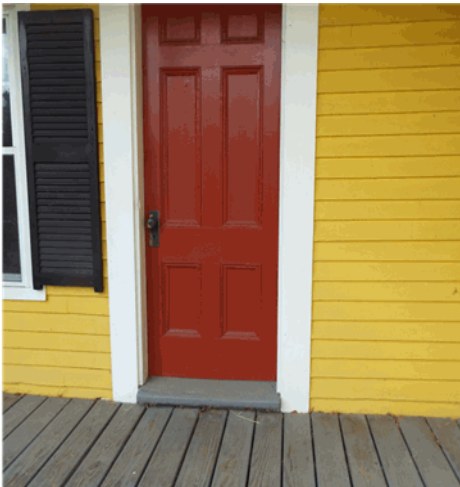
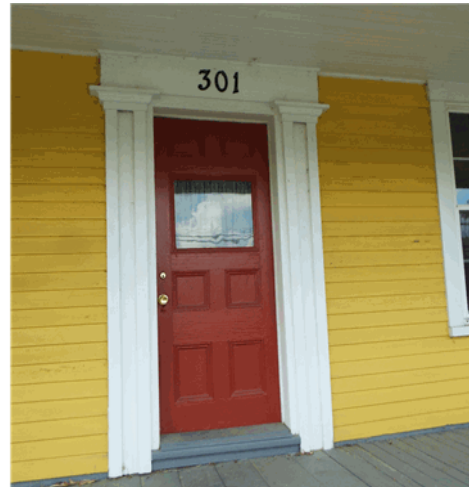
8) Exterior Door Conditions

The door(s) appeared to be in serviceable condition at the time of the inspection.

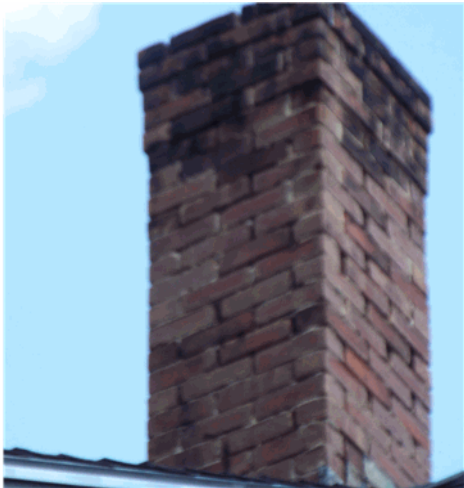
Recommend inspection by a qualified chimney specialist prior to using. The chimney and / or flue did not have a rain cap installed. Recommend a cap be installed during normal chimney maintenance. Maintenance on the brick of the chimney is needed.

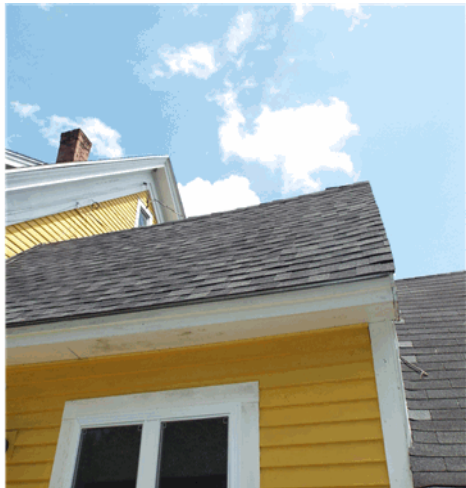
10) Roof Covering Condition

The roof covering shows normal wear for its age and appeared to be in serviceable condition at the time of the inspection.

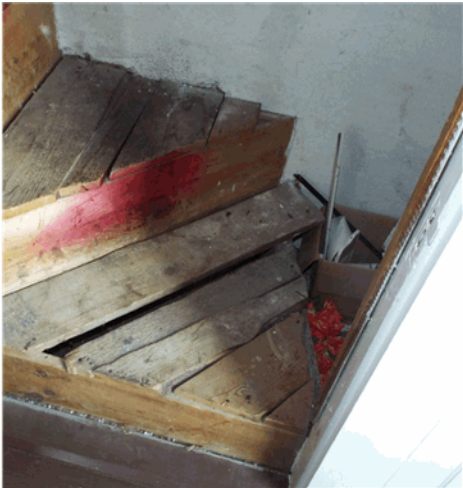
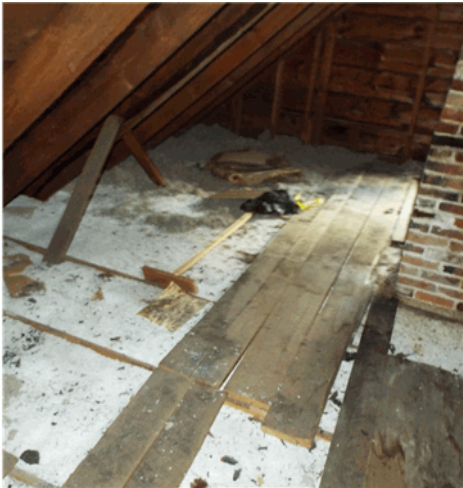
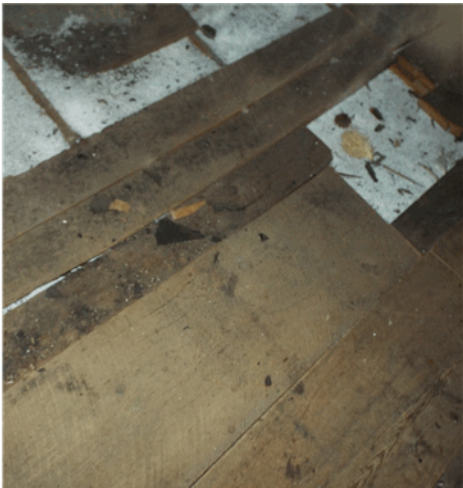
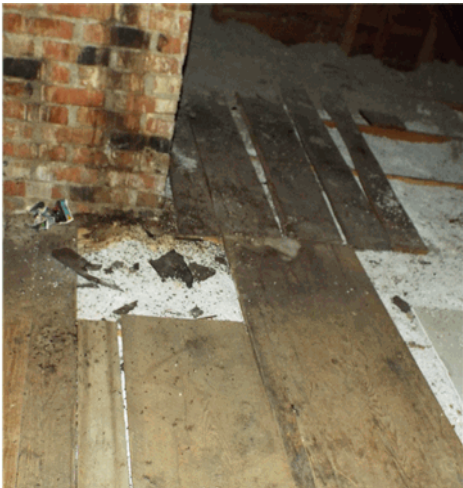
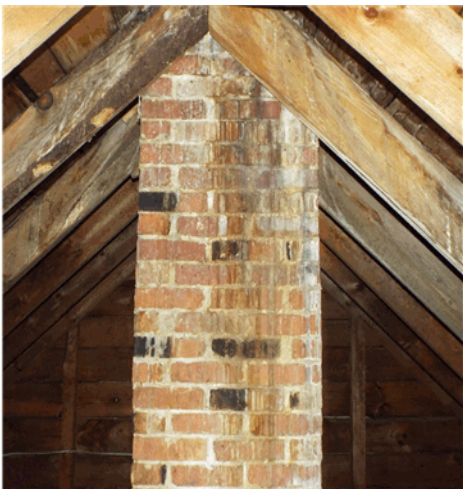
12) Attic Conditions

The visible and accessible portions of the attic appeared to be in serviceable condition at the time of the inspection. Evidence of rodents () were observed. While this observation may exist now, the occurrence may have been some time ago. Client should contact a pest control company for further evaluation.

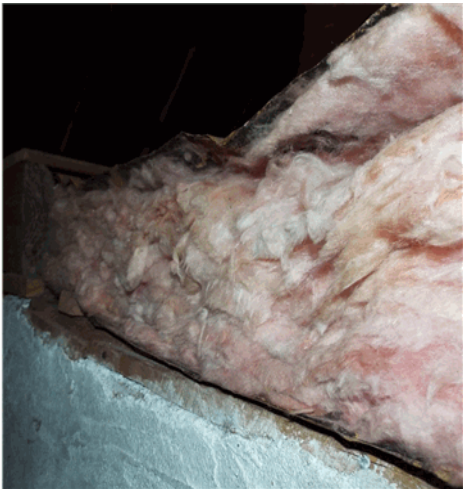
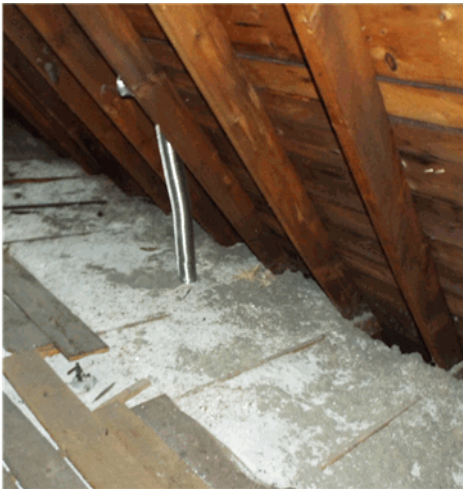
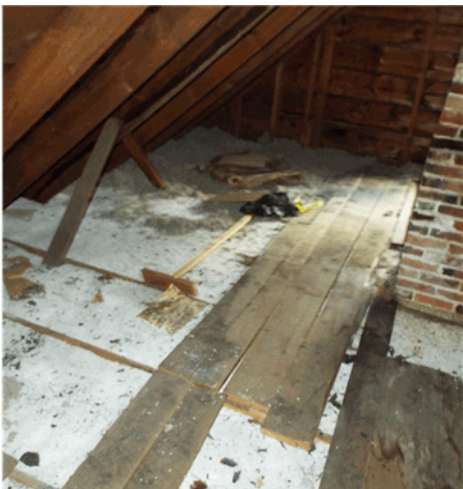
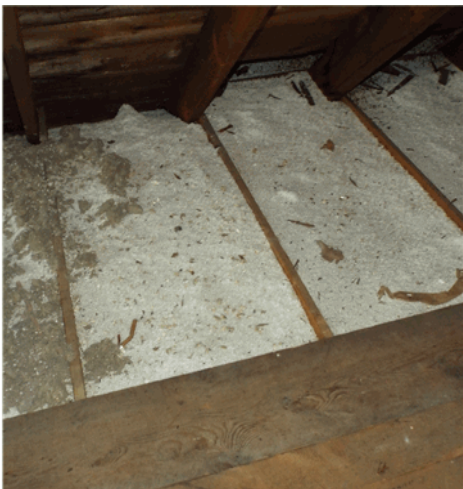
13) Attic Insulation Conditions AS The attic has minimal amount blown-in insulation and batt insulation. The approximate depth of the insulation is 6. Additional insulation should be considered.

Attic Ventilation Conditions Minimal ventilation was provided to the attic area. This may not be sufficient to move air through the attic properly. Recommend installing additional vents.

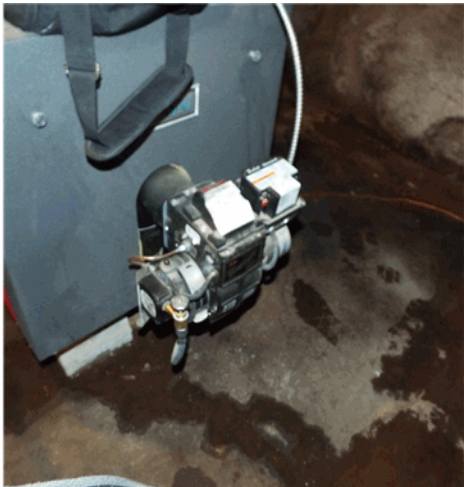
14) Unit Conditions

The heating system was operational at time of inspection. This is not an indication of future operation or condition.

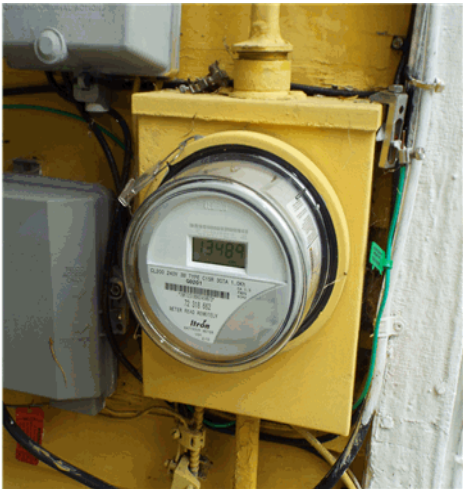
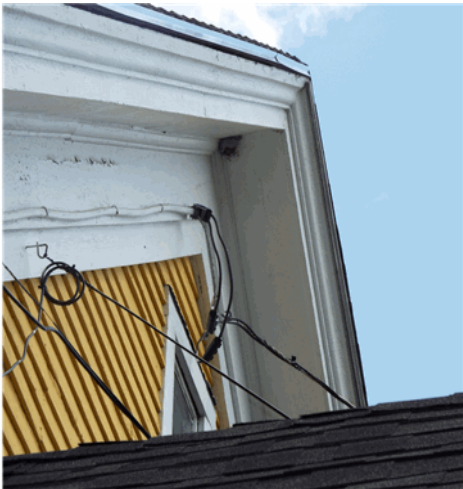
The main service entry appeared to be in serviceable condition at the
Conditions time of inspection.

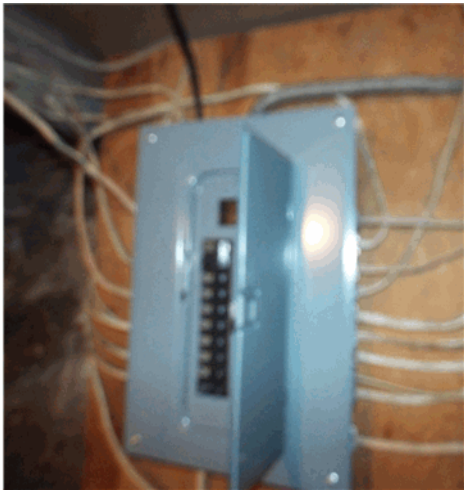
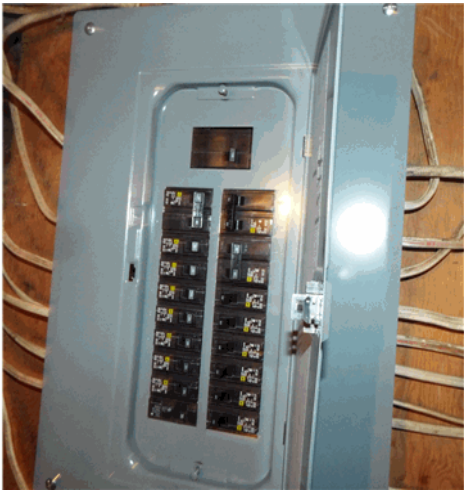
19) Electrical Panel
Conditions

The main panel appeared to be in serviceable condition at the time of the inspection.

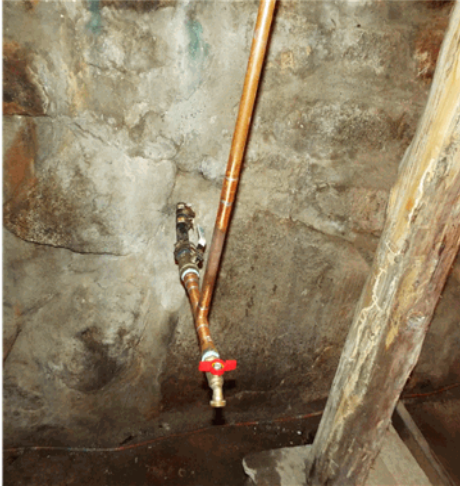
20) Main Line & Valve Conditions

The visible portion of the main pipe and valve appeared to be in serviceable condition at the time of the inspection.

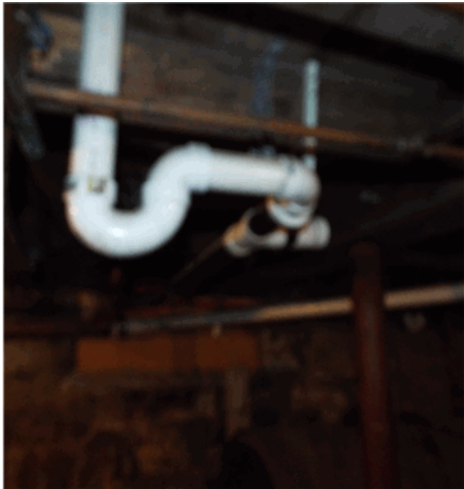
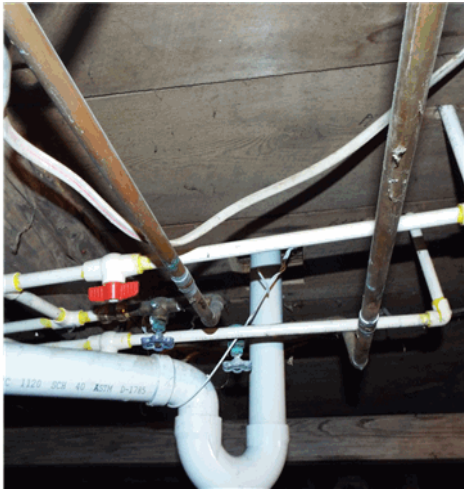
The visible portions of the waste lines appeared to be in serviceable condition at the time of inspection. All of the waste lines were not fully visible or accessible at the time of the inspection.

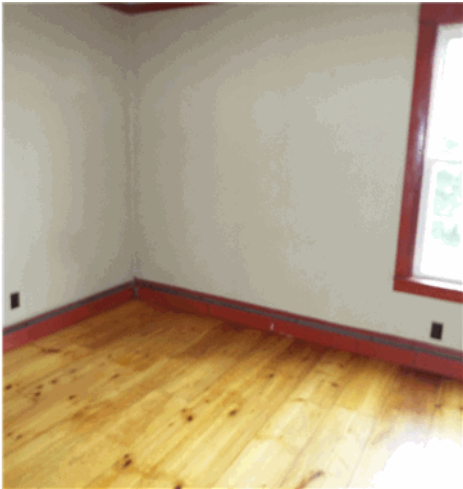
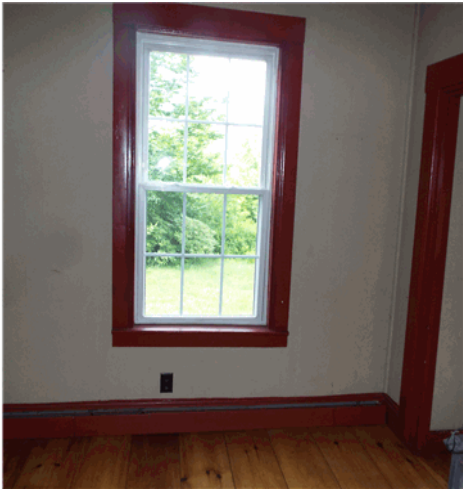
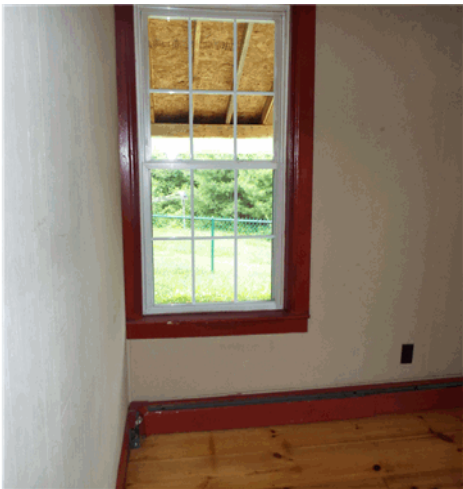
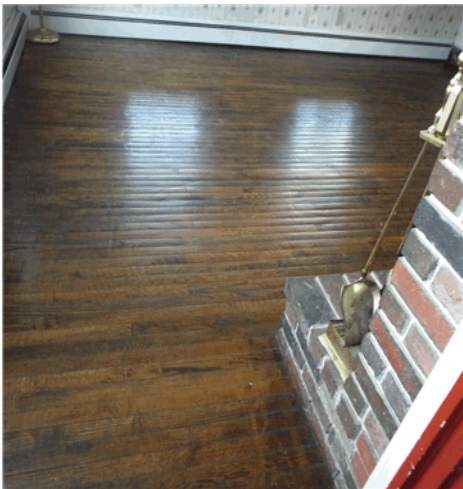
24) Walls - Ceiling -
Floors Condition

The general condition of the walls appeared to be in serviceable condition at the time of the inspection. Some rooms are under various stages of repair/renovation.

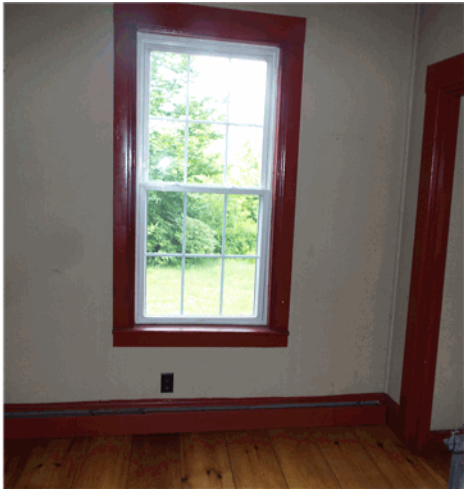
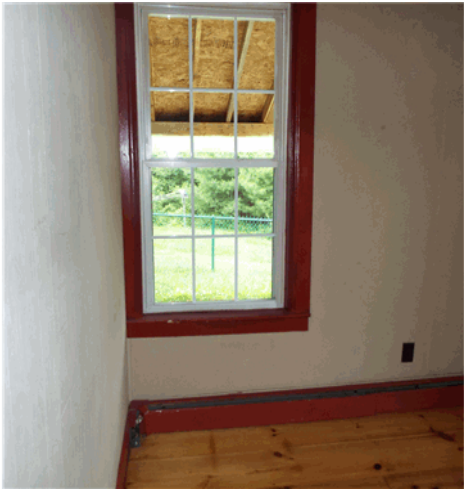
26) Interior Window
Conditions

The sample of windows tested were operational at the time of the inspection.

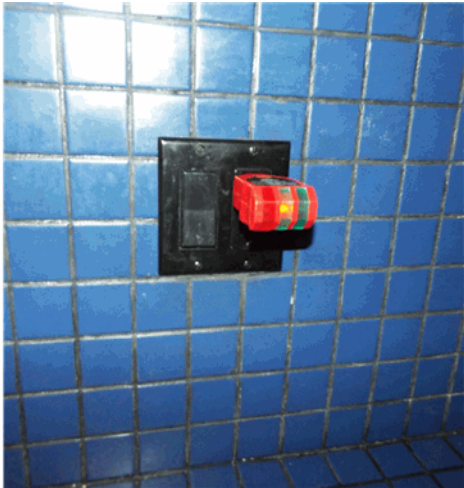
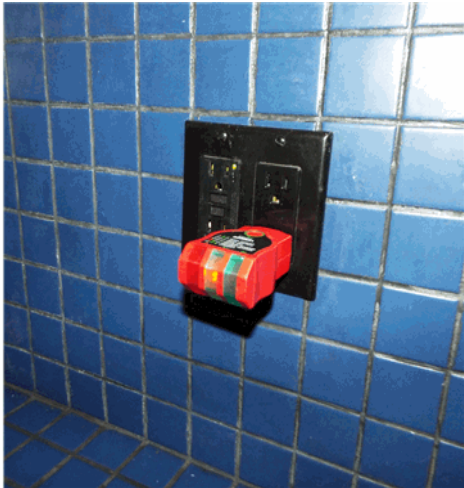
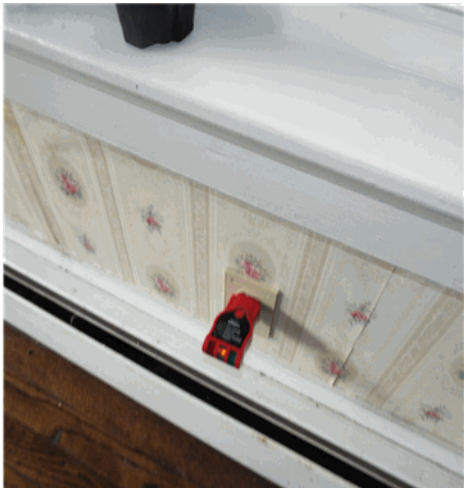
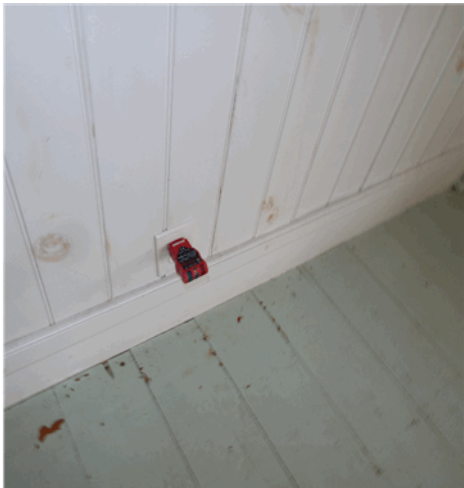
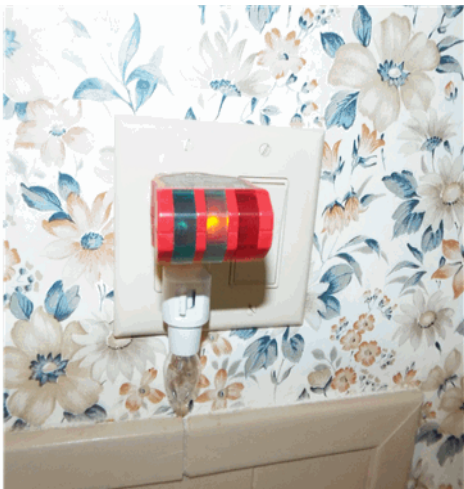
An open neutral wire condition was observed at multiple outlets. This condition is usually corrected by minor wiring adjustments at the specified item. However, when a number of these conditions are observed, client should consult a licensed electrician. Two prong (non-grounded) receptacles were observed. Although these were commonly used years ago, we recommend a licensed electrician upgrade to grounded three prong receptacles.

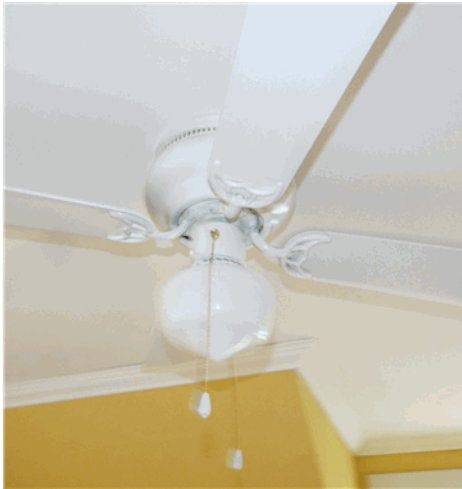
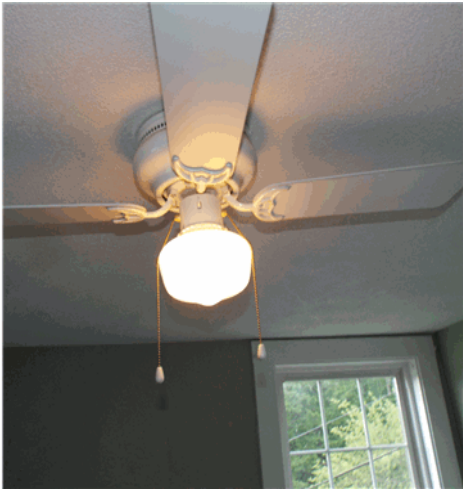
30) Ceiling Fan
Conditions

The ceiling fan(s) were operational at the time of the inspection.
Mounting hardware of fans, light fixtures, and / or chandeliers was not visible or accessible for inspection.

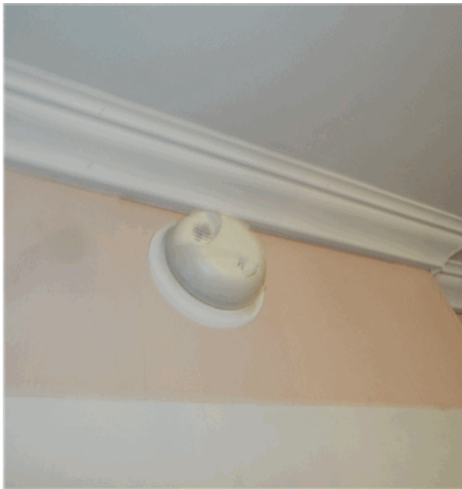
31) Smoke Detector
Conditions

Appeared to be in serviceable condition at time of inspection.
Recommend upgrading all to combination detectors.

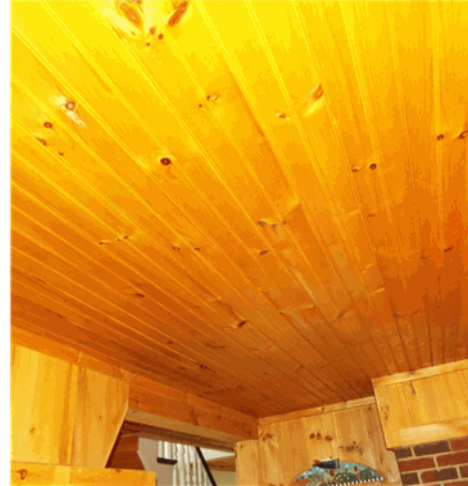
33) Wall - Ceiling - Floor Condition

The general condition of the walls appeared to be in serviceable condition at the time of the inspection.

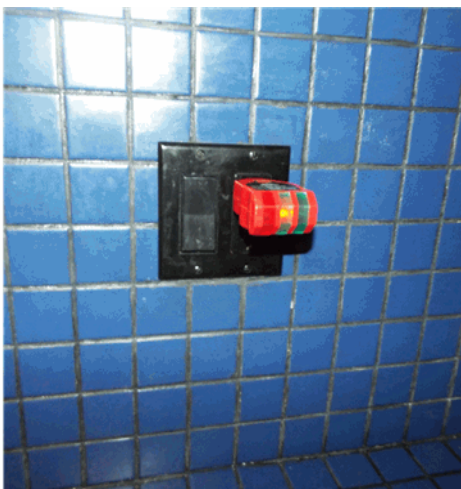
35) Electrical Conditions

An open neutral wire condition was observed in kitchen at many outlets. This condition is usually corrected by minor wiring adjustments at the specified item. However, when a number of these conditions are observed, client should consult a licensed electrician.

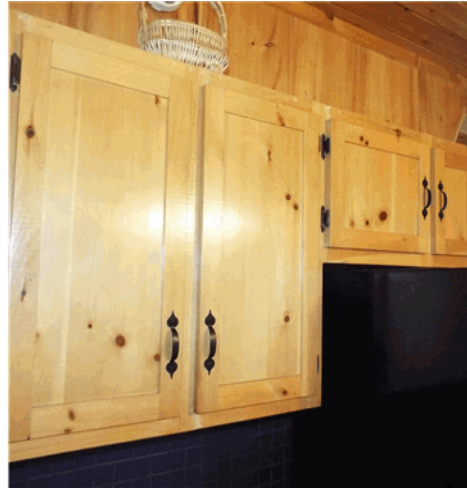
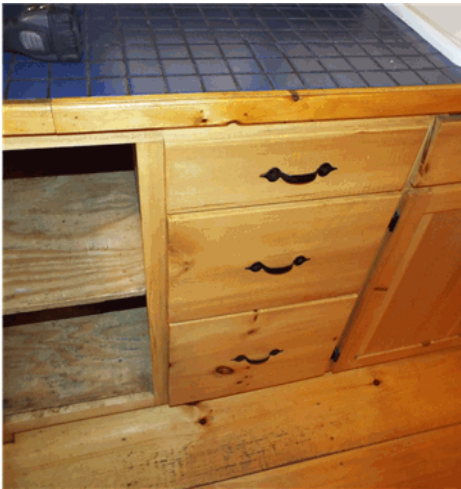
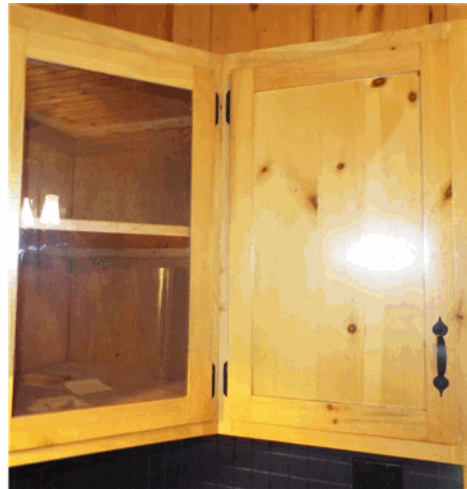
37) Counter - Cabinet Conditions

The visible portion kitchen counters appeared to be in serviceable condition at the time of the inspection.

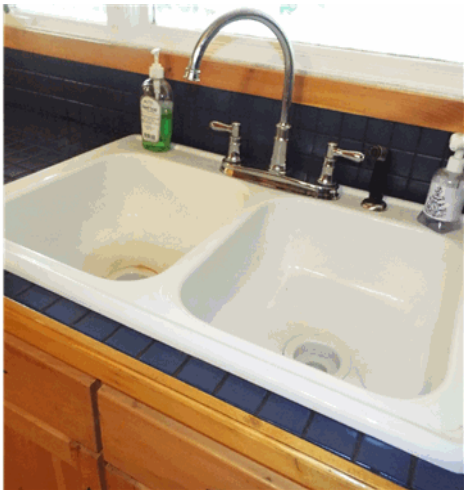
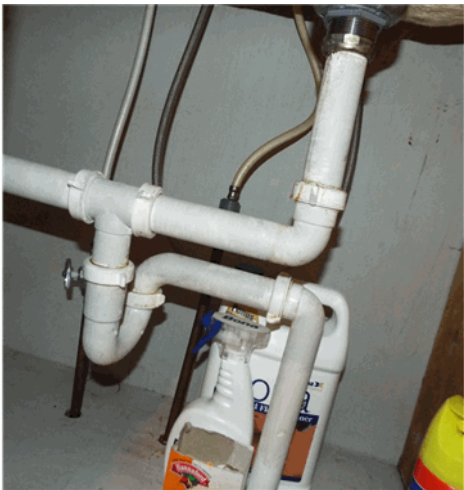
38) Sink Plumbing Conditions

The kitchen sink appeared to be in serviceable condition at the time of the inspection. The faucet appeared to be in serviceable condition at the time of the inspection. The visible areas of the plumbing under the kitchen sink appeared to be in serviceable condition at the time of the inspection.

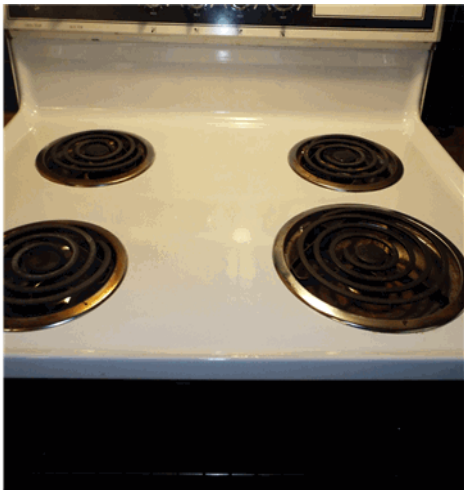
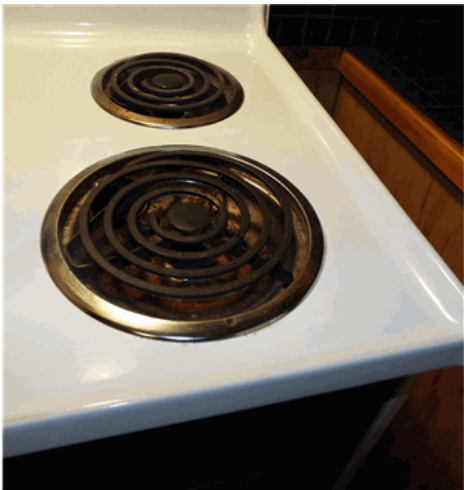
One burner did not operate. Oven door does not close tight.
Recommend repair.

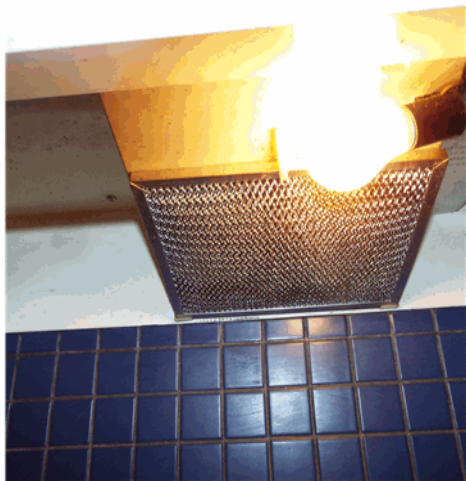
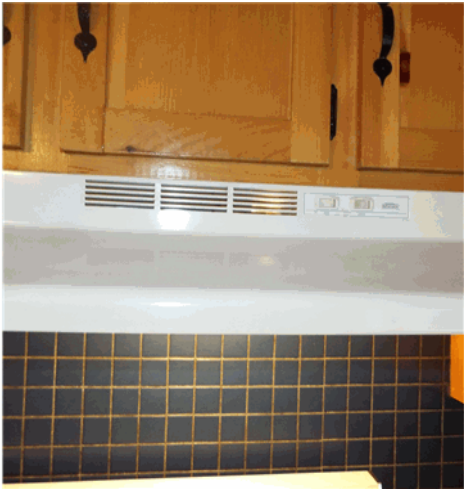
40) Hood Fan
Conditions

The fan / hood and light were in operational condition at the time of the inspection.

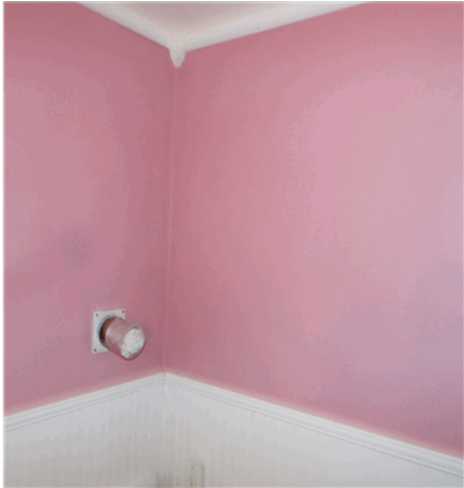
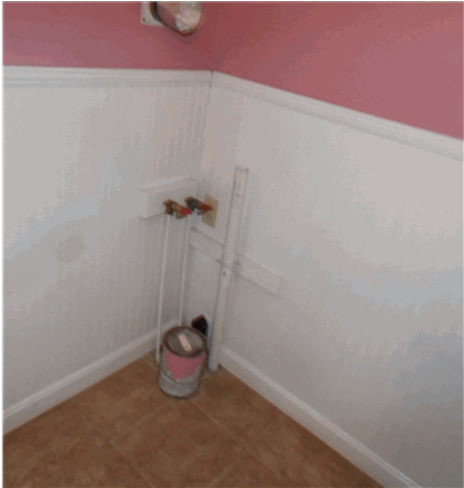
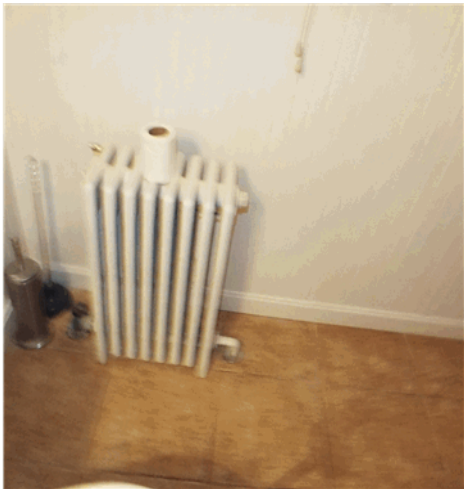
41) Wall - Ceiling -
Floor Conditions

The general condition of the walls appeared to be in serviceable condition at the time of the inspection.

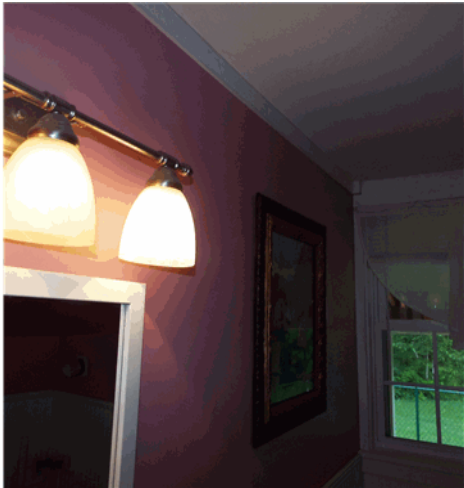
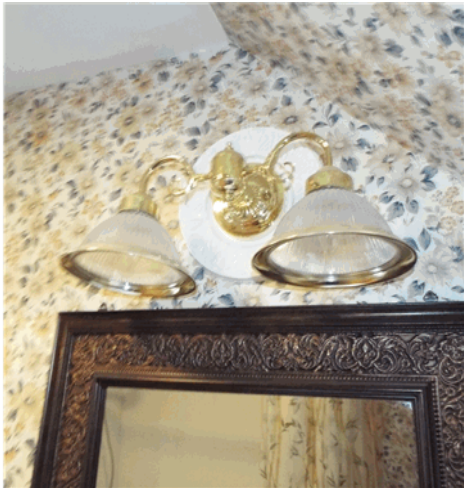
45) Lighting Conditions

Appeared to be in serviceable condition at time of inspection

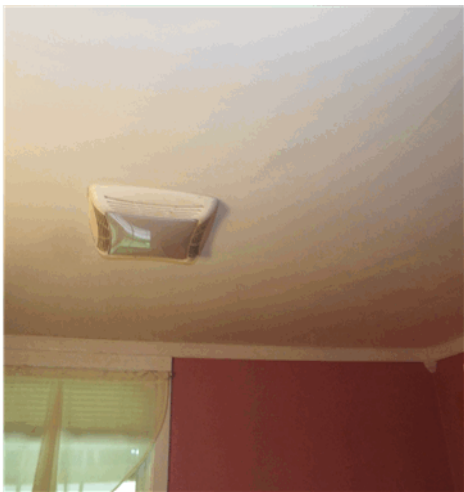
**46) Vent Fan
Conditions**

Operating at time of inspection

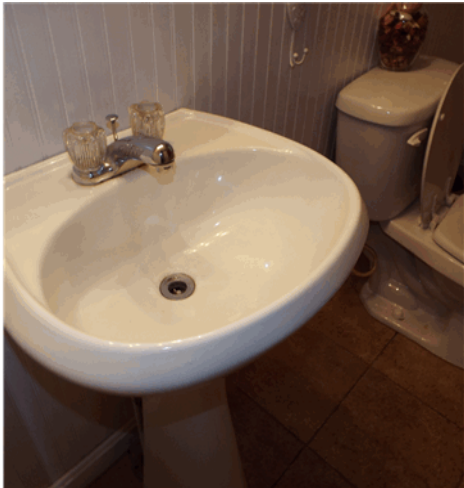
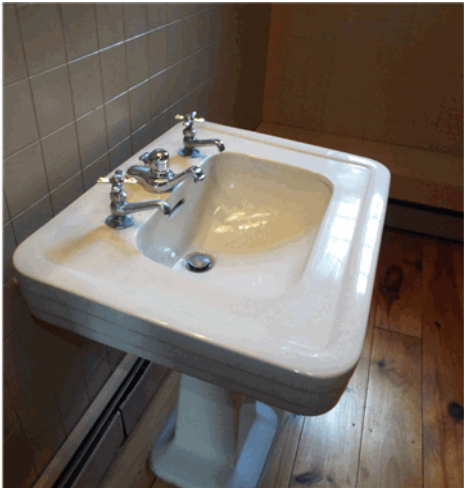
48) Sink Conditions

The sink appeared to be in serviceable condition at the time of inspection in bath

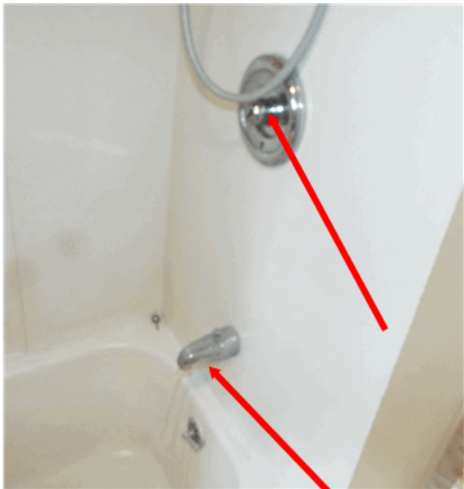
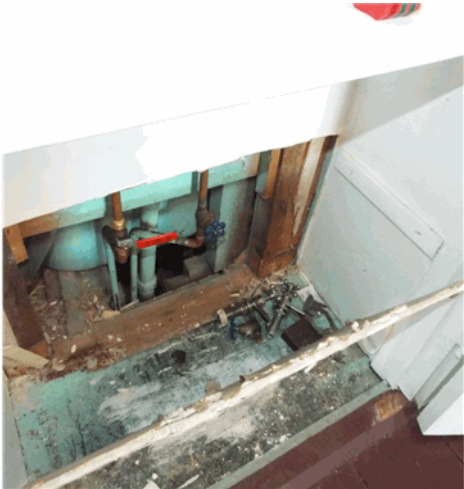
There was evidence of corrosion and / or damage at the bathtub faucet in upstairs. The bathtub to shower diverter valve stem leaked in bath. Recommend repair. bath. Recommend repair and/or replacement.

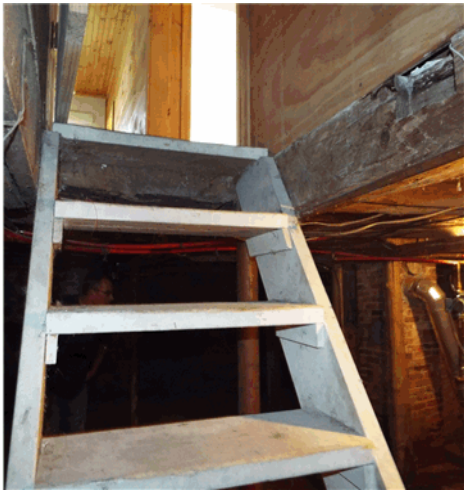
Basement stairs are too steep which is potentially unsafe to walk on.

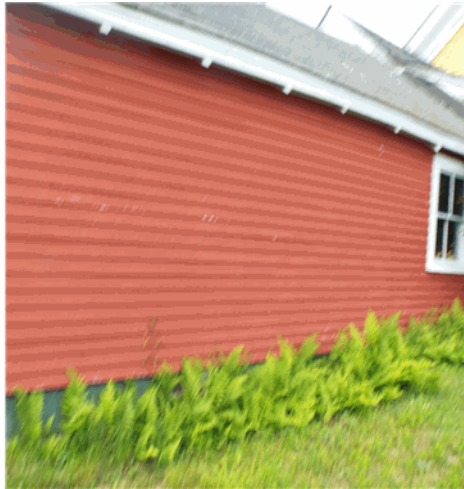
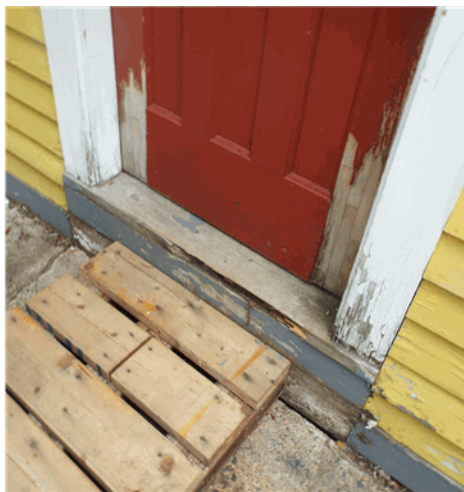
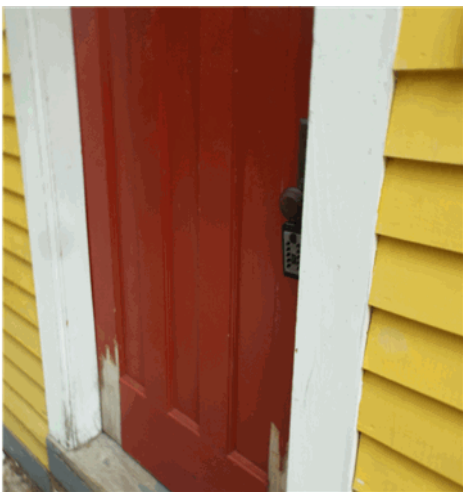
AS The paint / finish of the siding was deteriorated and is in need of repair, replacement and / or maintenance.

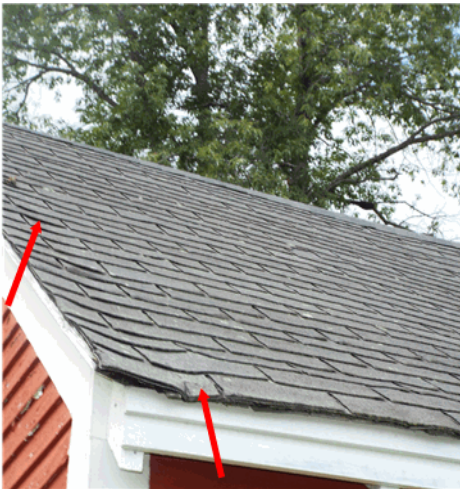
55) Roof Conditions (if detached)

The roof showed advanced signs of aging and deterioration. This condition can indicate imminent leakage. Replacement is recommended. Recommend further evaluation by a qualified roofing contractor. Two layers of roof shingles appear to be present. Today's standards allow a maximum of two layers of shingles. Client should obtain full disclosure / history information from the seller prior to close. The roof rafters have bowed and will need to be shored up. It is suggested that a "Licensed General Contractor" be contacted for further evaluation and repair.

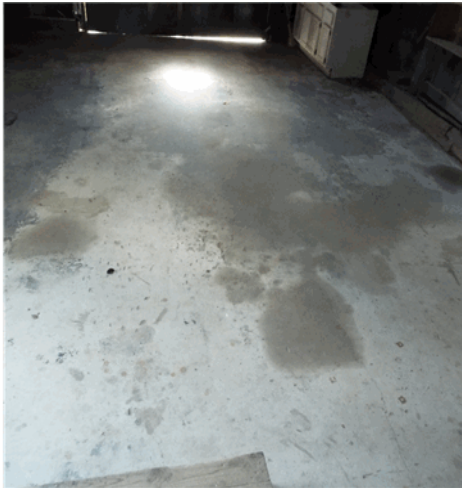
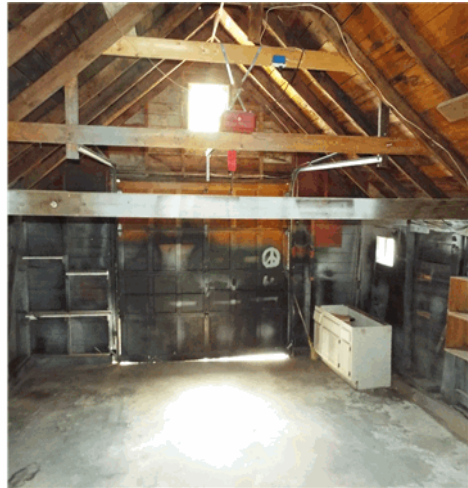
**56) Wall - Ceiling -
Floor Conditions**

The general condition of the walls appeared to be in serviceable condition at the time of the inspection.

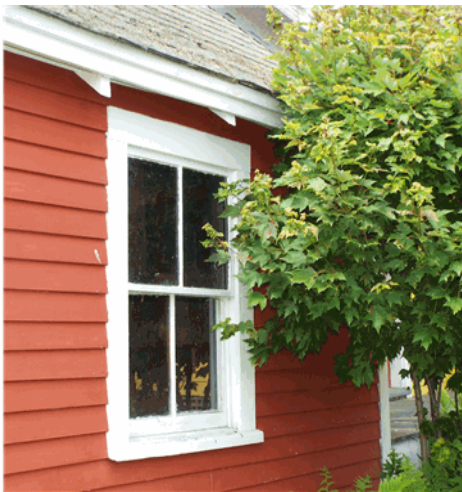
57) Window Conditions

Appeared to be in serviceable condition at time of inspection.

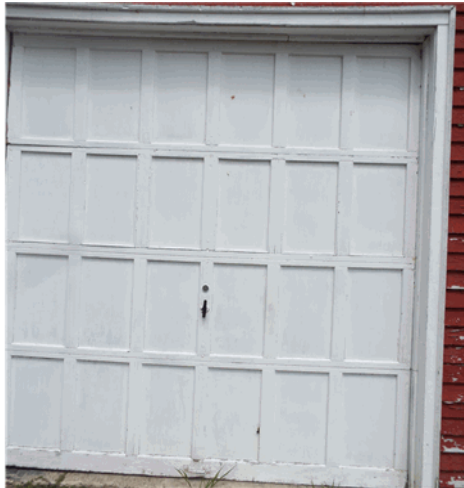
58) Vehicle Door Conditions

The vehicle door(s) appeared to be in serviceable condition at the time of the inspection.

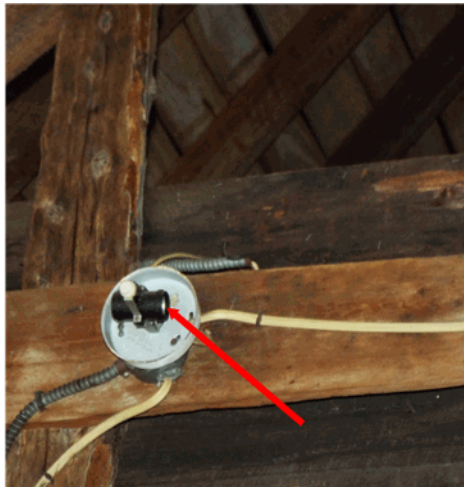
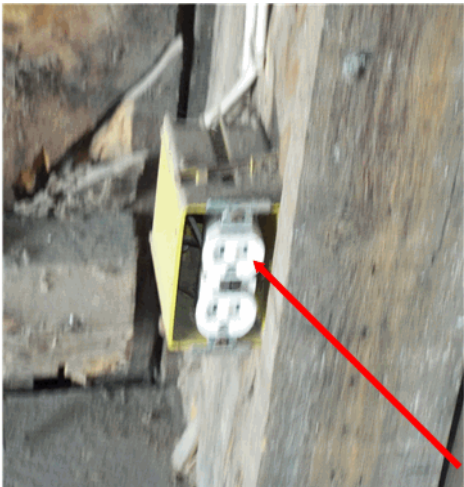
59) Electrical Conditions

Missing receptacle or switch covers were observed at. Recommend covers be installed for safety. An open neutral wire condition was observed at an outlet(s) located at. This condition is usually corrected by minor wiring adjustments at the specified item. However, when a number of these conditions are observed, client should consult a licensed electrician.

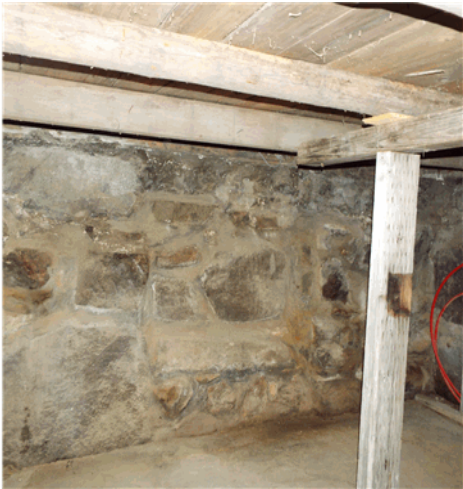
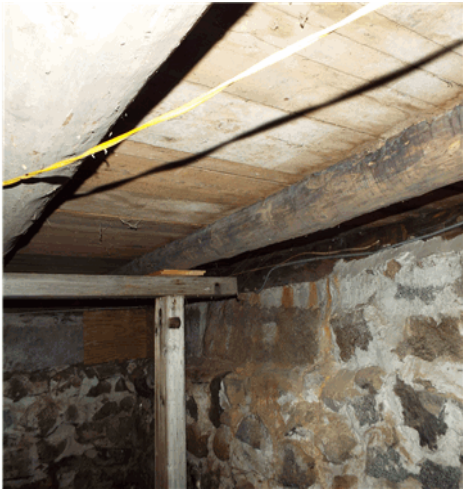
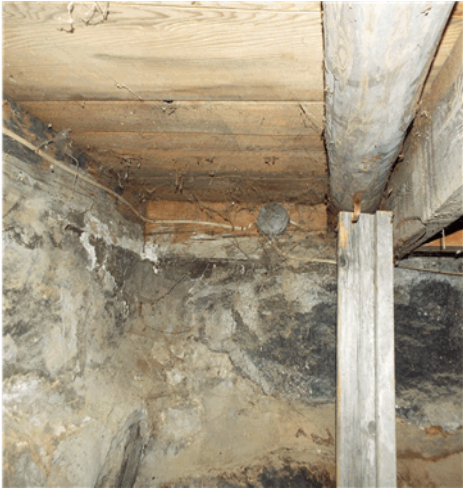
61) Foundation
Conditions

Appears Serviceable Minor moisture stains were observed on the foundation walls. This may be an indication of water penetration, which is not unusual for a block/stone foundation. The inspector was unable to determine if the water stains were active or passive at the time of inspection. Client should obtain disclosure / history information from the seller regarding any previous water penetration.

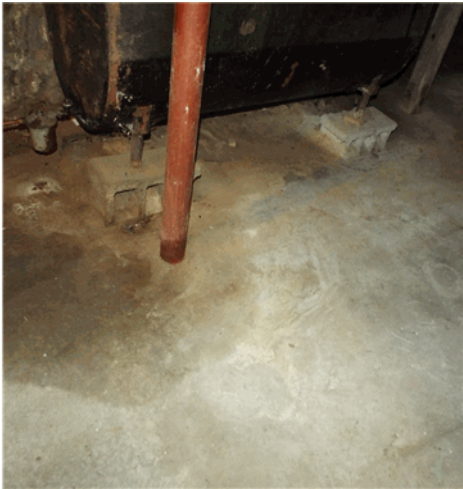
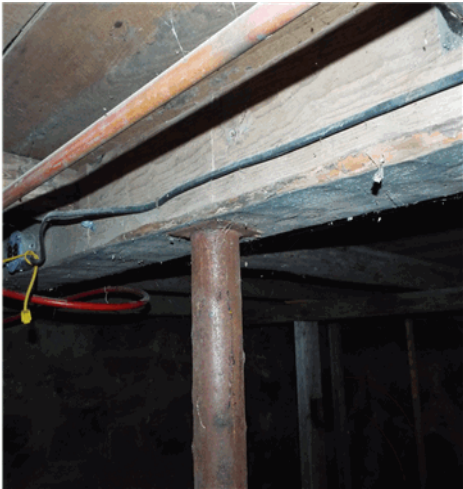
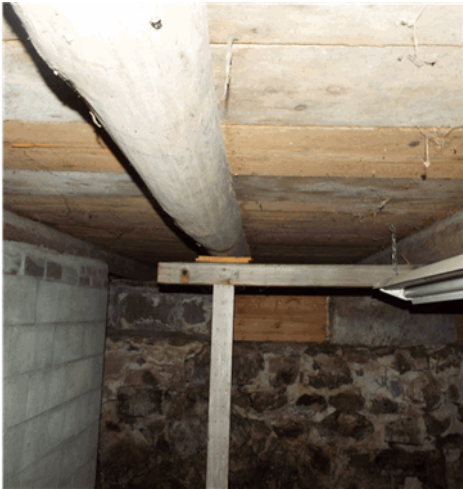
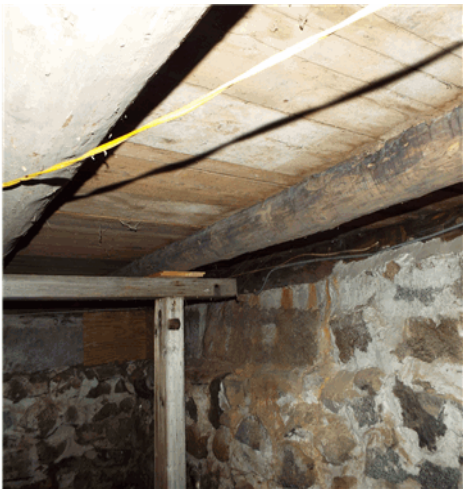
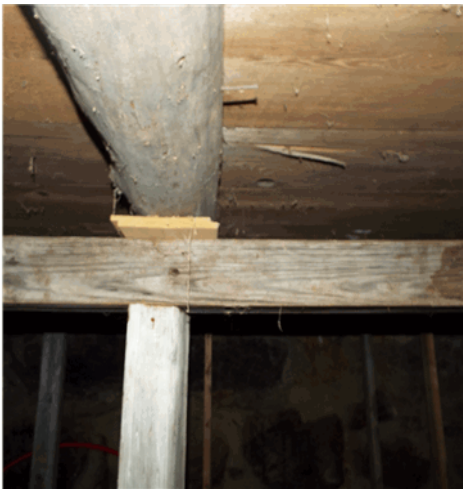
**62) Flooring Support
Conditions**

The visible and accessible areas of the wood framing system appeared to be in serviceable condition at the time of the inspection.
