Inspection Report

Northeast Expedite Home Inspections LLC

Sanford, Maine
04073

Inspection Date July 18, 2007

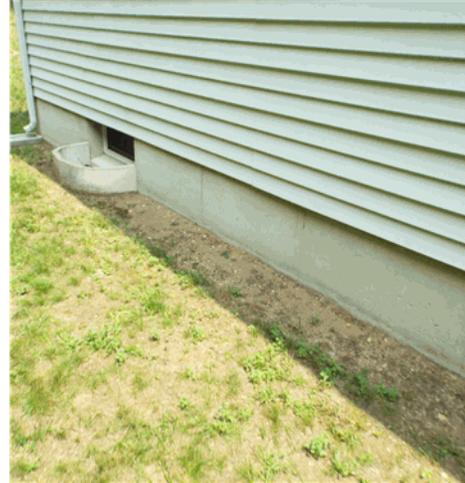
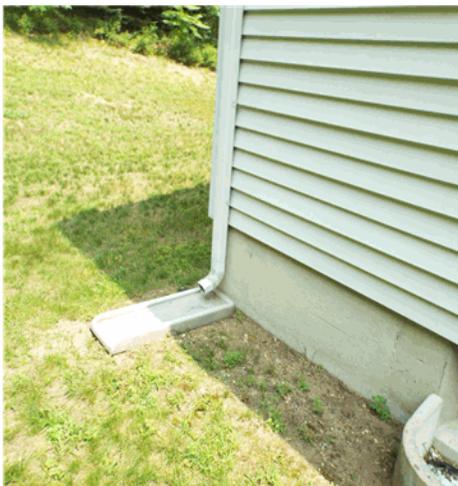
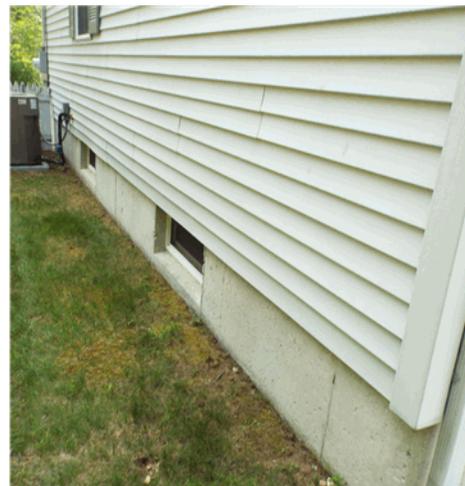
1) Grading Conditions AS Grading of the soil near the foundation appears to be in serviceable condition.

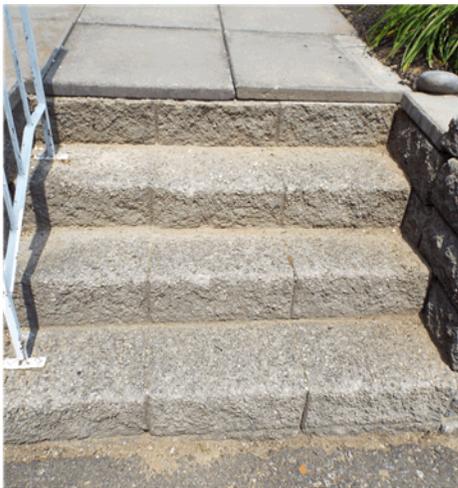
3) Walkway Conditions

The visible areas of the sidewalk appeared to be in serviceable condition at the time of the inspection.

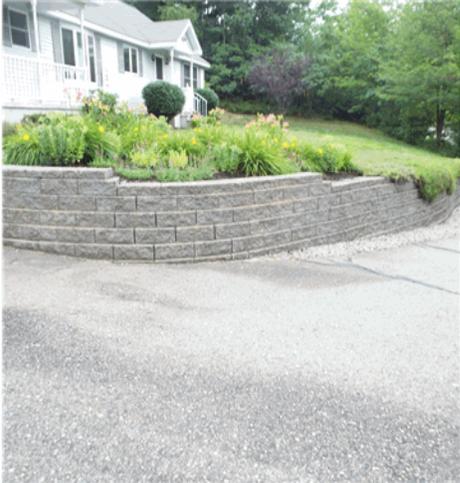
4) Retaining Wall Conditions

The visible and accessible portions of the retaining walls appeared to be in serviceable condition at the time of the inspection.

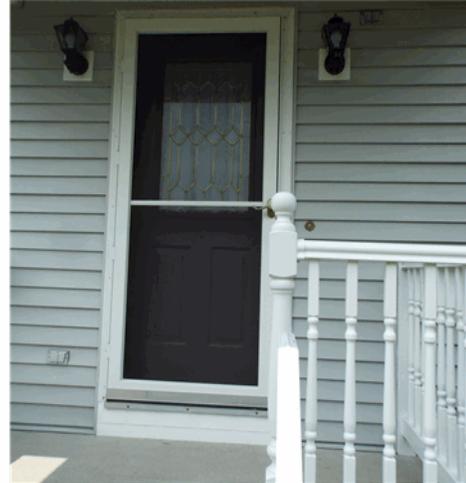
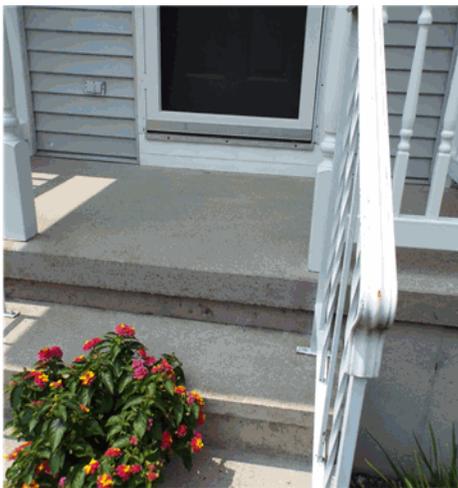
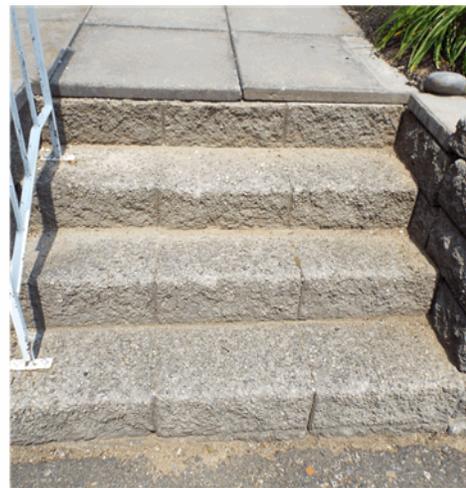
5) Front Entrance
Conditions

Appeared to be in serviceable condition at time of inspection

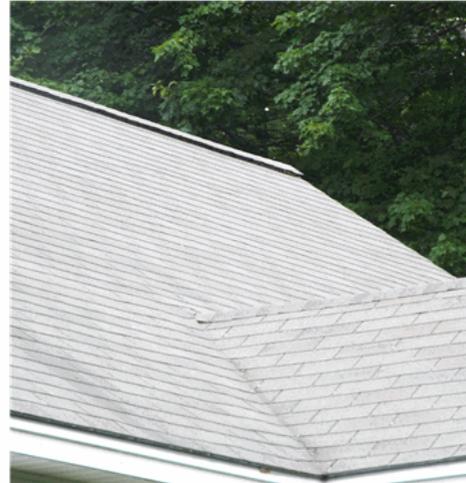
11) Roof Covering Condition AS This is the original roof covering and appears to be in serviceable condition at the time of inspection. The roof covering is at the verge or end of it's natural service life and has stood up well. I recommend monitoring condition on an annual or semi annual basis.

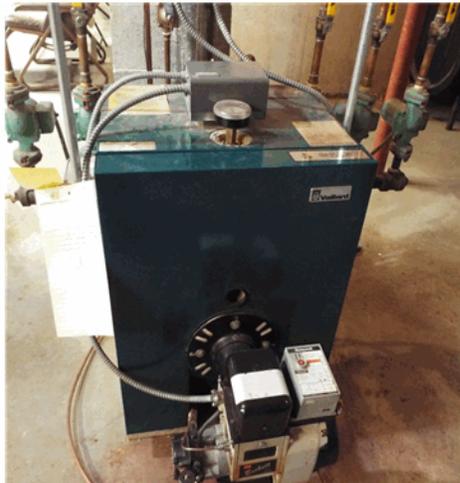
16) Unit Conditions AS The heating system was operational at time of inspection. This is not an indication of future operation or condition.

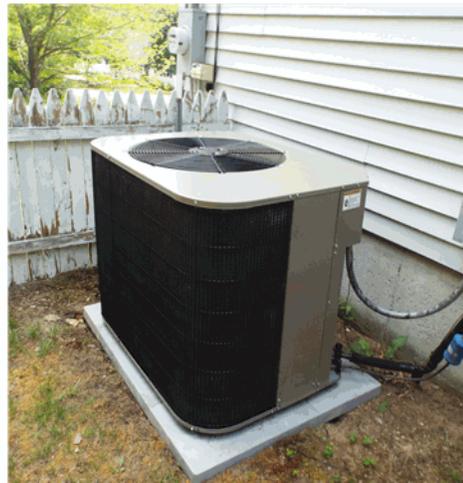
19) AC Unit Conditions

Appeared to be in serviceable condition at time of inspection.

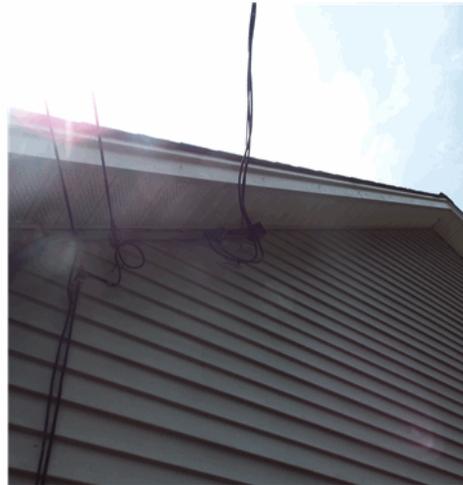
20) Electrical Service Conditions AS The main service entry appeared to be in serviceable condition at the time of inspection.

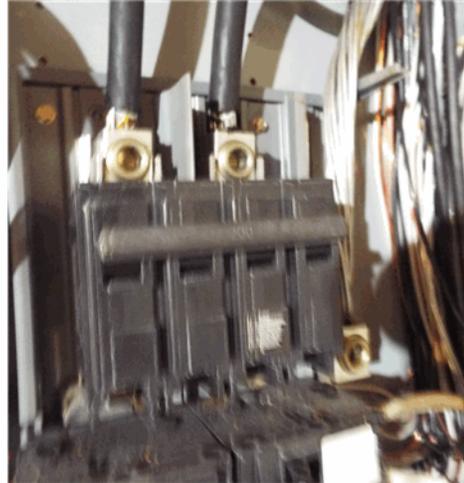
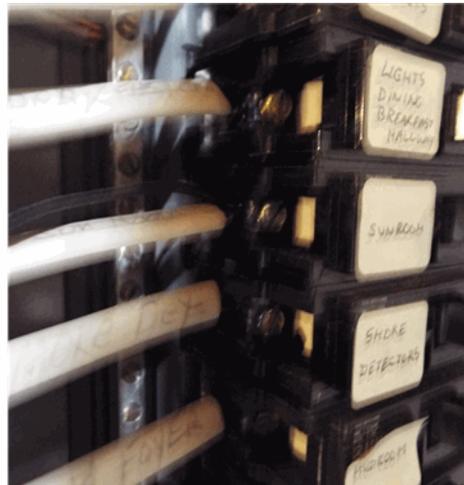
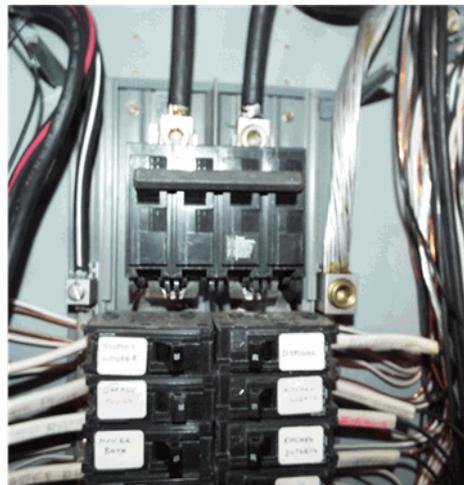
22) Electrical Panel Conditions

The main panel appeared to be in serviceable condition at the time of the inspection. Two or more wires were connected to one breaker in the panel. This condition can add to the load of the affected electrical circuit(s) causing a possible overload, tripping, or arcing at the breaker(s). Current standards require circuits to be independently protected. Recommend an electrician properly separate circuits.

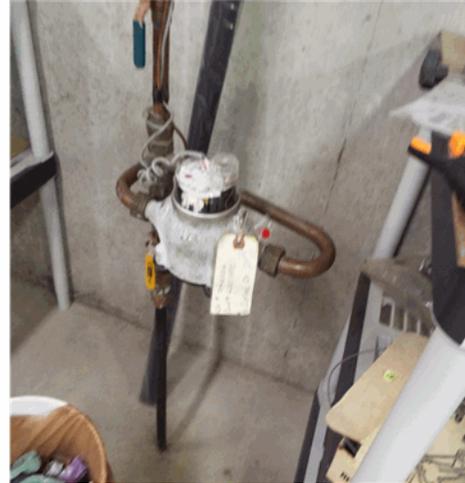
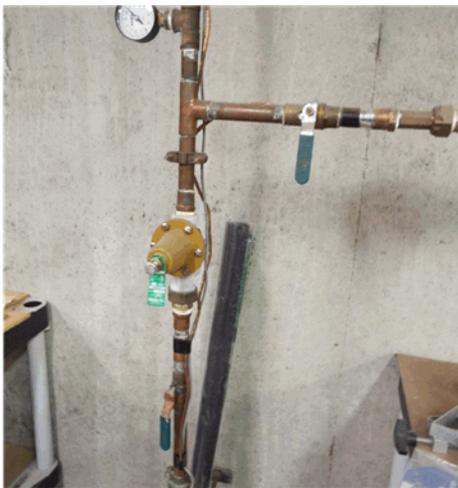
24) Main Line & Valve Conditions

The visible portion of the main pipe and valve appeared to be in serviceable condition at the time of the inspection.

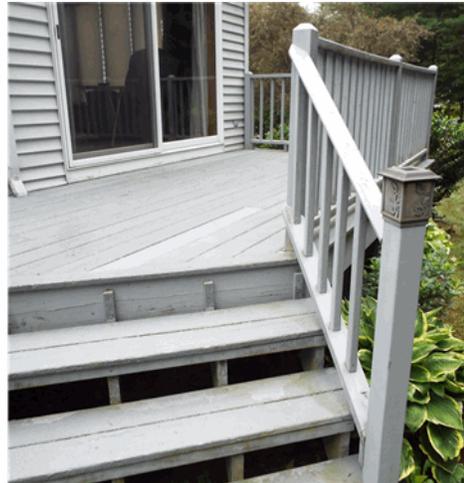
61) Deck

Several deck boards were rotted and will need to be replaced. There may be other boards damaged that were not visible during inspection.

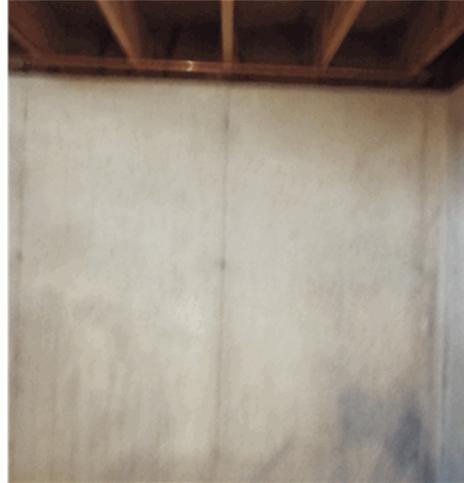
66) Foundation Conditions AS Appeared to be in serviceable condition at time of inspection.
